LANDSLIDES AND RELATED FEATURES

OF THE HEBBERTSBURG, TENN. QUADRANGLE

by
Roger E. Thomas and Alfred R. Taylor

U.S. Geological Survey
OPEN FILE MAP 82-653 (A-10)

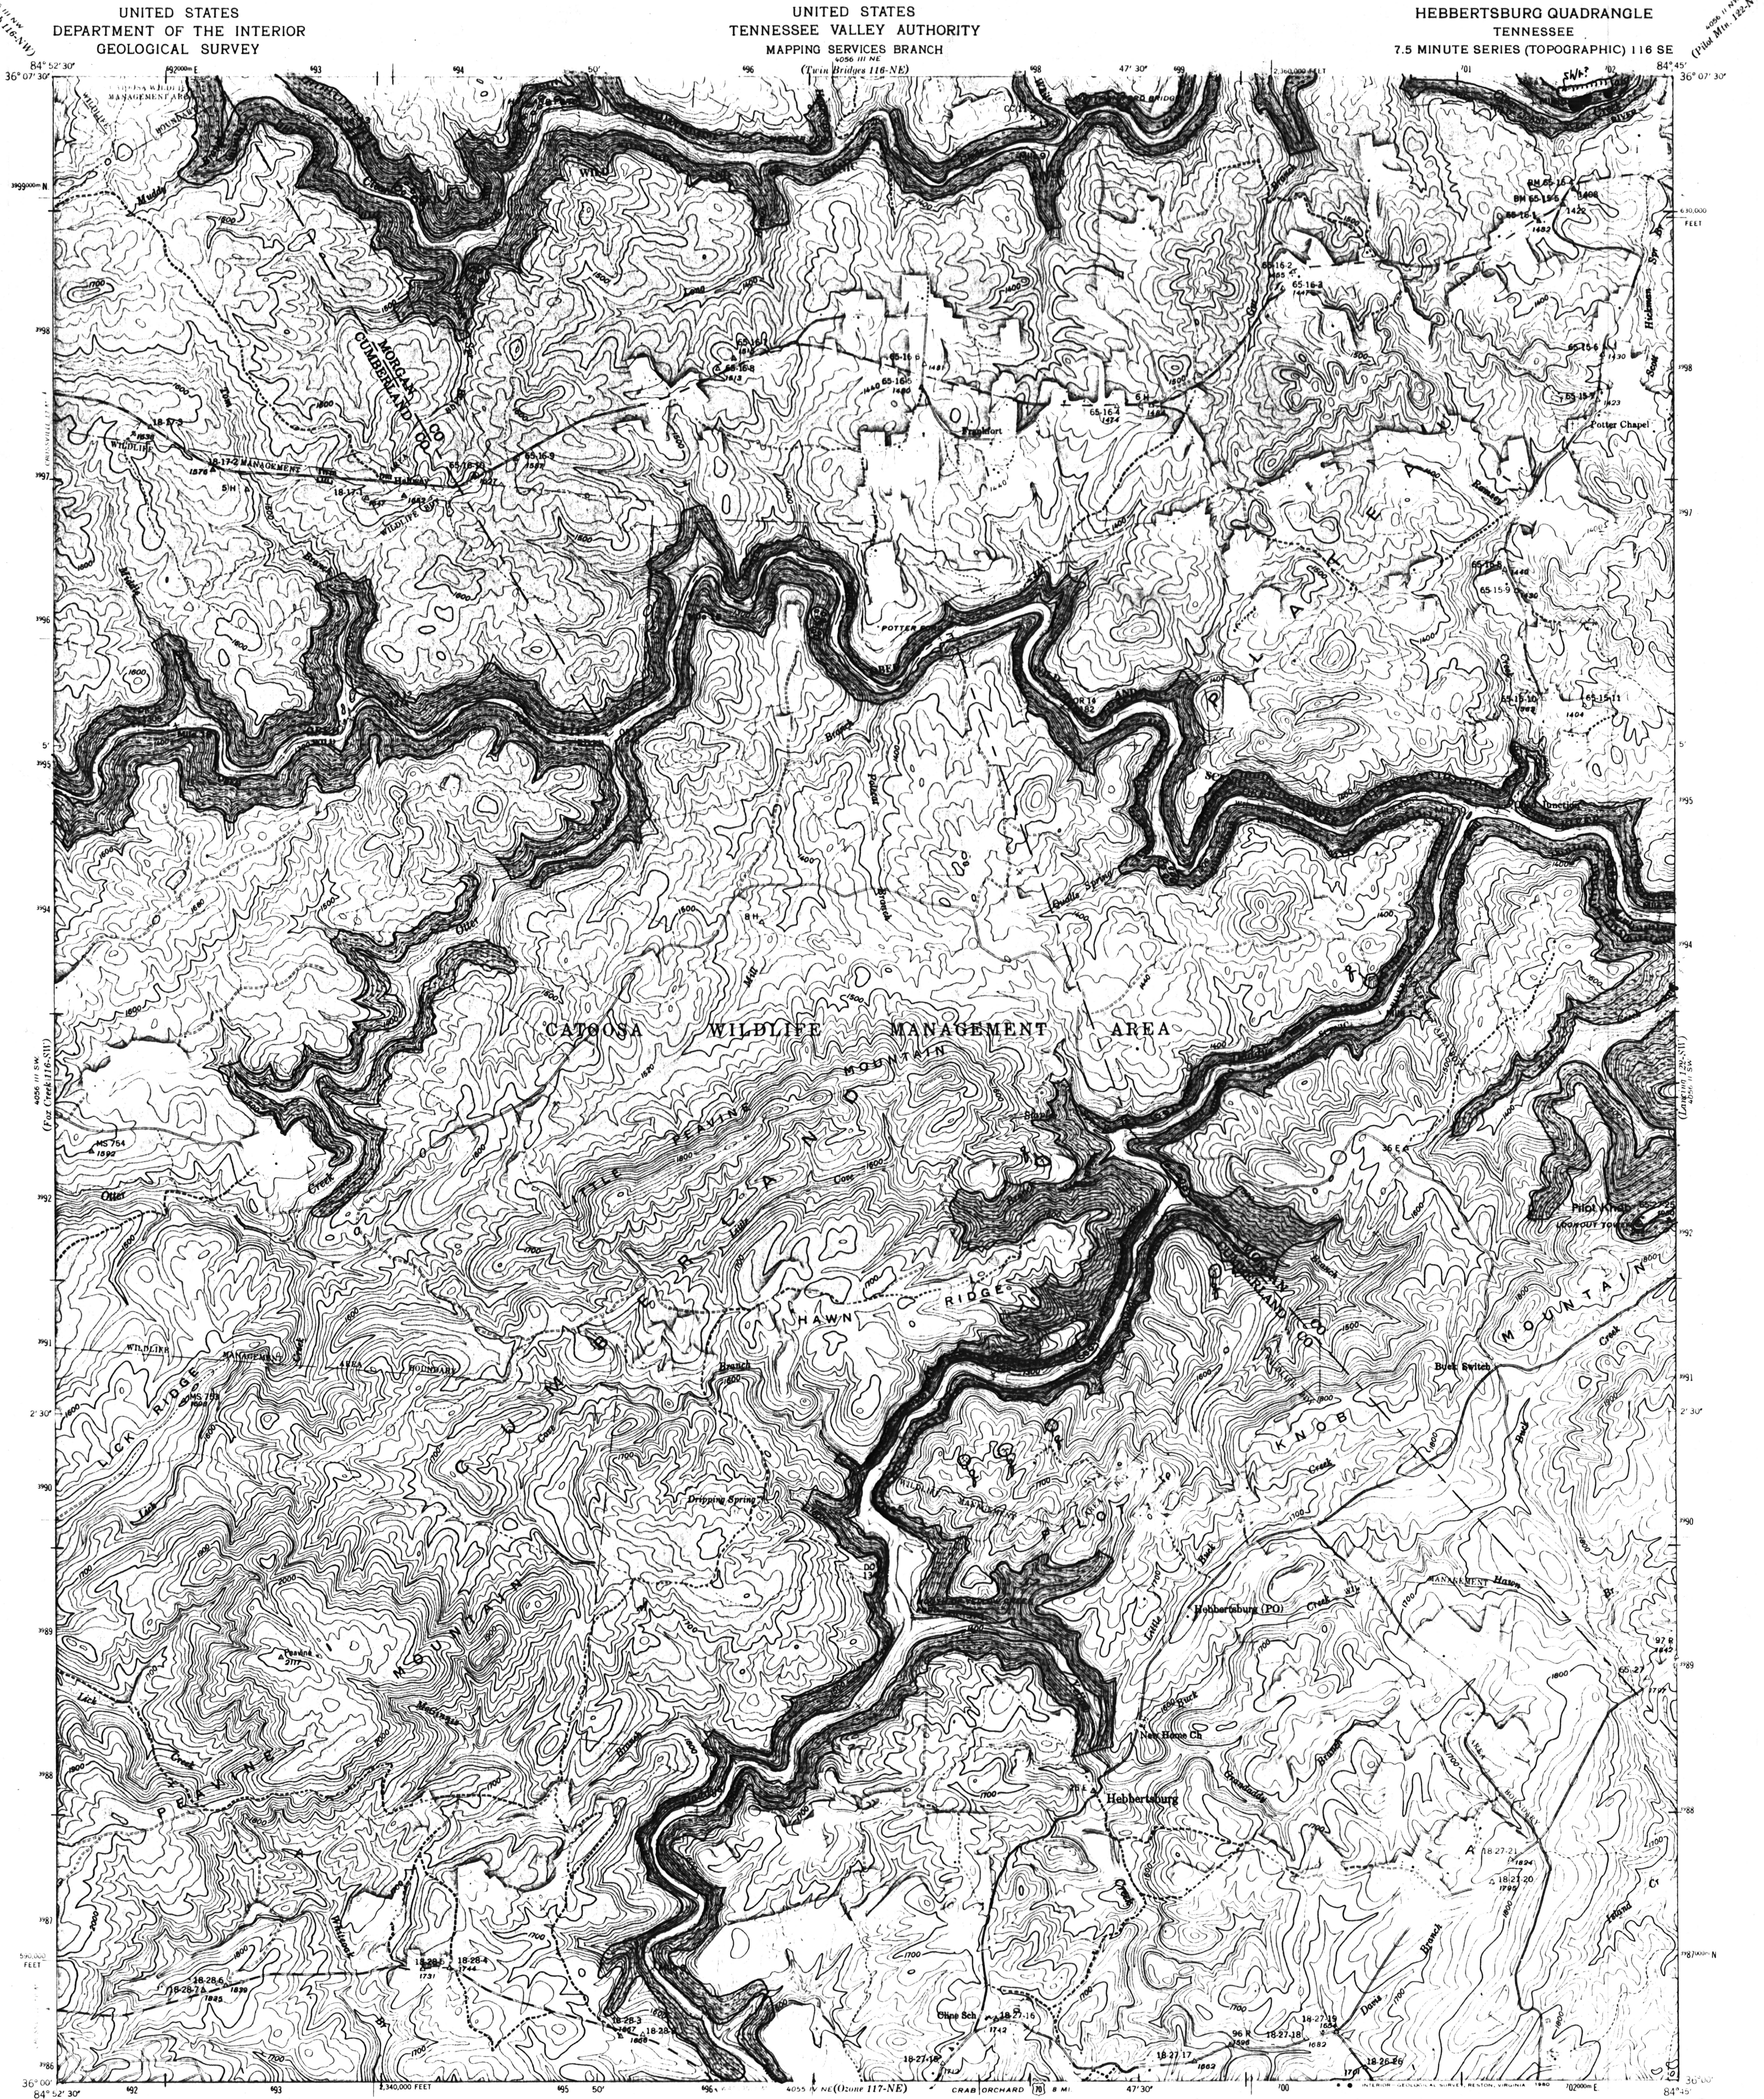
HEBBERTSBURG, TENN.
N3600-W8445.7.5
1943

Landslides and related features interpreted
from aerial photographs:

Photointerpretation and field check 1979-1980, 1982.

ACTIVE OR RECENTLY ACTIVE LANDSLIDE
Complex landslide composed of earthflow, debris
slide, earth and rock slump. Identified from
historical records, and from scars, debris and
other field evidence. Ground extremely unstable;
sliding accelerated by excavation, loading and
changes in drainage conditions. May include
areas with several active slides too small to
be shown separately. Questioned where doubtful.

OLD LANDSLIDE
Area of extensive hummocky ground caused by
earthflow and earth and rock slump. Lacks
clear evidence of active sliding. Relatively
stable in natural, undisturbed state,
generally not affected by small structures properly
sited in areas away from the edge of the toe;
can be reactivated by extensive, rapid exca-
vation, loading, and changes in ground water and
surface water conditions. Area of old landslide
probably includes recent ones not identified
from field evidence or otherwise documented.
Upslope boundary of landslide generally defined
by modified scarp, but downslope (toe) may be
gradational and not well defined. Questioned
where doubtful.

COMBINATION LANDSLIDE
Area of recent and old slides in which
individual slides are not identified.

COLLUVIAL SLOPE
Valley wall along major streams with slope as
steep as 40° (85%); stony, clayey silt soil up
to 50 ft. (15 m) thick; commonly buttressed by
a terrace or bench at the toe of the slope; very
susceptible to sliding by cutting of toe area,
removal of terrace or bench, and overloading;
slide commonly activated without apparent cause.

COLLUVIAL SLOPES WITH LANDSLIDES
Landslides too small or obscure to map
individually.

**AREAS SUSCEPTIBLE TO DEBRIS FLOWS AND DEBRIS
AVALANCHES**
Primarily shallow, narrow ravines and chutes with
accumulation of stony colluvium generally 10 ft.
(3 m) or less in thickness; susceptible to rapid
movement during intense rainfall. Most ravines
and chutes designated show evidence of former
debris flows and avalanches.

AREAS SUSCEPTIBLE TO ROCKFALL
Steep, locally vertical, natural and man-made
slopes and cliffs, 15 ft. (4.5 m) or more high;
formed dominantly of sandstone, limestone, sandy
shale, mudstone and claystone. Interbedded mud-
stone, claystone and shale weather rapidly leaving
sandstone and limestone rock faces unsupported.

SOIL AND ROCK SUSCEPTIBLE TO LANDSLIDING
Soil and rock similar to that involved in land-
slides elsewhere in map area; primarily areas
underlain by claystone, mudstone and shale
associated with other rock types. Rock weathers
rapidly on exposure forming clayey soil highly
susceptible to sliding. Includes coves (U-shaped,
shallow valleys) containing thick layers of clayey
soil that are very susceptible to sliding where
excavation breaks continuity of slope and where
overloaded by artificial fill.

AREAS LEAST PRONE TO LANDSLIDES
Map areas in which no patterns or symbols are shown;
primarily valley floors, ridge tops and broad
benches; modification by excavation and fill may
lead to local landslides.
